REPORT ON A PCB SPILL ON OCTOBER 8, 1980
AT ISABELLA STREET SCHOOL
THUNDER BAY, ONTARIO

NORTHWESTERN REGION
ONTARIO MINISTRY OF THE ENVIRONMENT
November, 1980

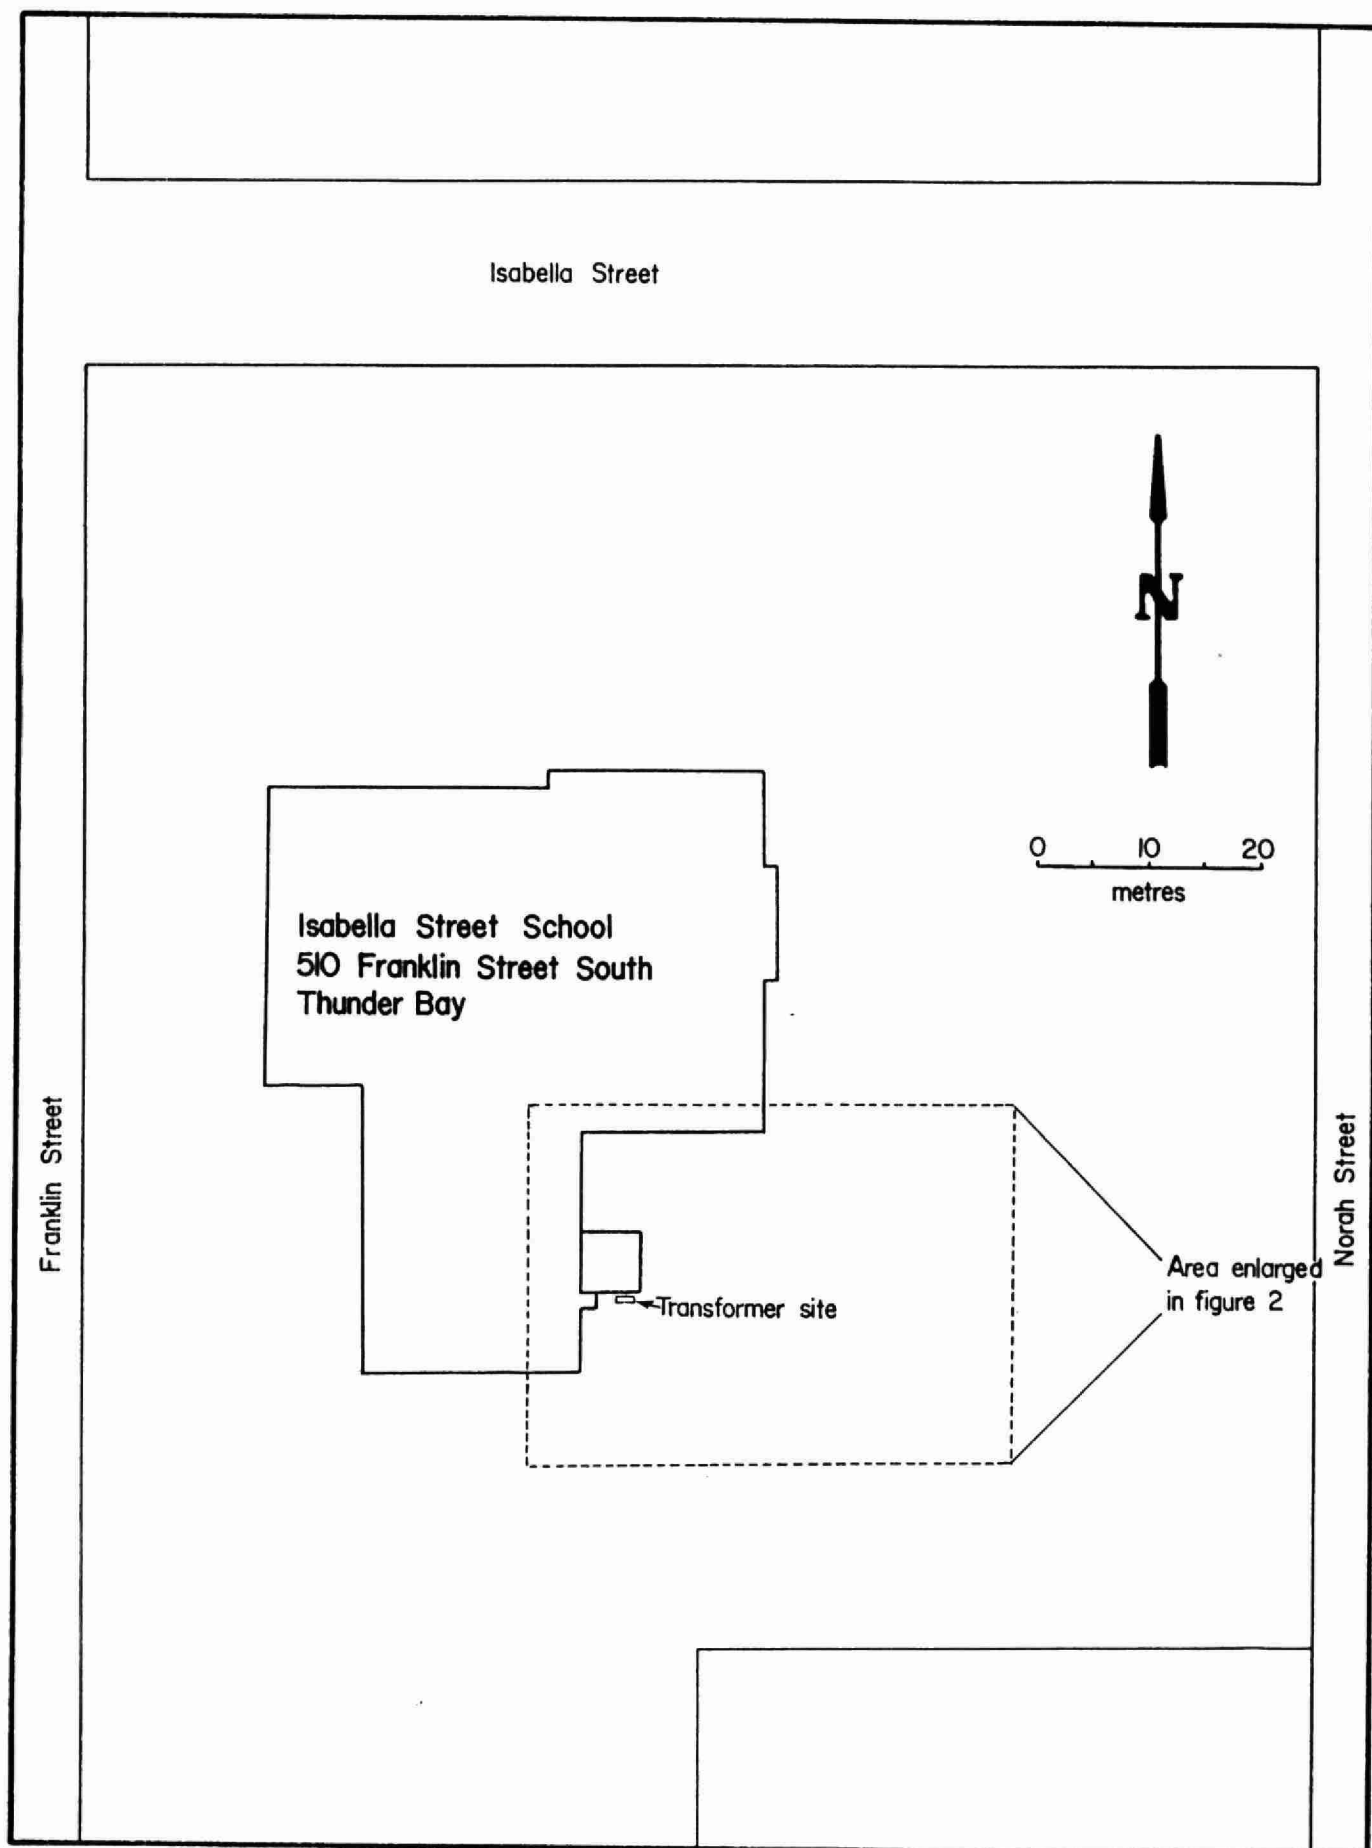
Figure 1. Isabella School grounds, Thunder Bay .

To resolve concerns about possible contamination of groundwater in the area surrounding the spill site, four test boreholes were drilled at locations approximately 10 m from the transformer (Figure 1). These holes extended a short distance below the surface of the water table. Samples of wet soil from this depth (2-2.5 m) in each hole were tested by the Ministry's Toronto laboratory and found to contain virtually no PCB's. This finding indicates that there was no lateral movement of PCB's from the spill site. Because the general area is very flat and the soil at water table depth is of low permeability, the lateral movement of groundwater was not expected to move at a rate exceeding a few metres per year. As a final assurance that no groundwater contamination had occurred, water draining into the boiler room sump from the tile beds along the footings of the building was also sampled. Since this water contained less than 1 $\mu\text{g/l}$ (microgram of PCB's per litre of water), there was no evidence that any PCB compounds had moved from the contaminated site to the drainage area around the base of the school.

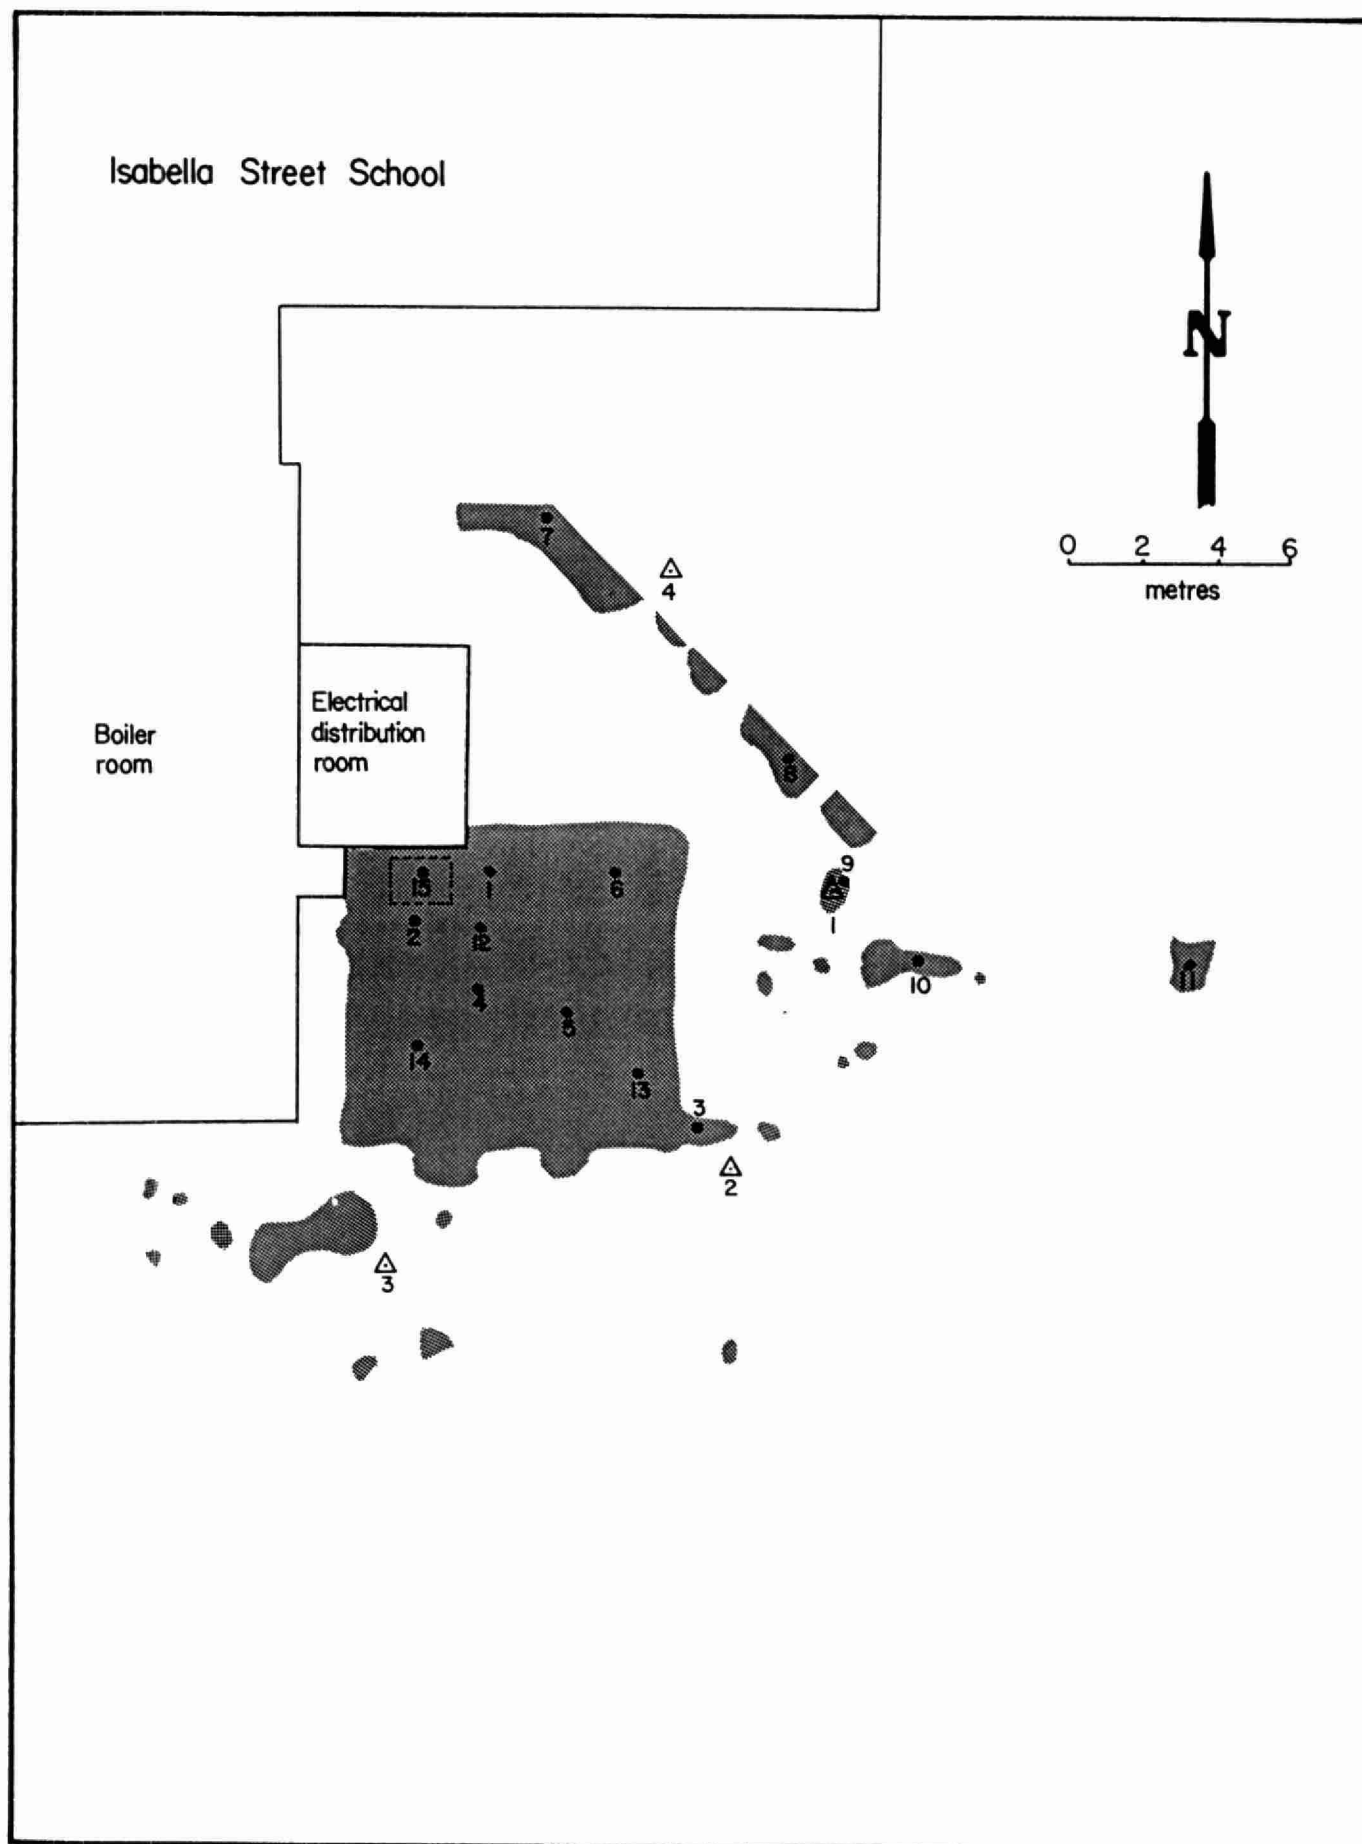
Figure 2. Excavation areas in vicinity of ruptured transformer, Isabella Street School.

The samples from October 10 showed that there was significant contamination in surface soil near the transformer. After approximately 0.6 m of soil was removed within 3 m of the transformer, and 0.3 m excavated from the rest of the main excavation area and the isolated outer patches, the whole area was resampled on October 12. This second set of samples showed that the isolated outer pockets were free of contamination but that significantly elevated PCB was still present within 5 m of the transformer. The excavation was deepened to approximately 1.5-2 m within 2-3 m of the transformer, and to 0.5-0.7 m in the area at a lateral distance of 3-8 m from the transformer. Under the transformer site itself, a pocket of darkly-stained soil, with a strong "askarel" odour, was encountered at a depth of 2-2.5 m. The occurrence of this area of highly contaminated soil (3400 $\mu\text{g/g}$), was completely unexpected. Transformer fluid leakages in past years may have caused this contamination, but there are no historical records to support or deny this assumption. Several sessions of careful manual digging, interspersed with sampling on October 16

and 19, were required to remove this soil. The final depth of excavation was approximately 3 m, which was about 0.5 to 1.0 m below the water table. The last set of soil samples showed that PCB concentrations did not exceed 5 $\mu\text{g/g}$. The base of the walls of the excavation contained $< 1 \mu\text{g/g}$ PCB's. To replace the 300-odd drums of contaminated material removed, approximately 50 m³ of clean fill was dumped in the hole on October 21.

Sampling site (see Figure 2)	Distance (metres) and direction from transformer	Sampling date (October, 1980)				
		10 ^a	12	14	16	19
1	2 m E	1600 19	1700	10		
2	2 m S	860 51	180	24		
3	10 m SE	2 <1				
4	4 m SSE		250			
5	5 m SE		100	<1		
6	5 m E		300	<1		
7	10 m NNE		<1			
8	10 m NE		<1			
9	10 m E		<1			
10	13 m E		<1			
11	21 m E		<1			
12	3 m SE			<1		
13	8 m SE			17		
14	5 m S			<1		
15	nil			3400	72 ^b	5 ^c
